## Heritage Preservation Commission Regular Meeting

Tuesday, February 24, 2026, 6:30 PM  
106 Center Street

Before the Heritage Preservation Commission (HPC) tonight is a Site Alteration Permit application for the demolition of the rear 55 feet of the Tonka Theater building and the entire 1989 addition located at 26 Water Street. A staff report dated January 27, 2026, and a draft HPC Resolution 2026-01, provide staff's analysis of the Site Alteration Permit application and recommended action.

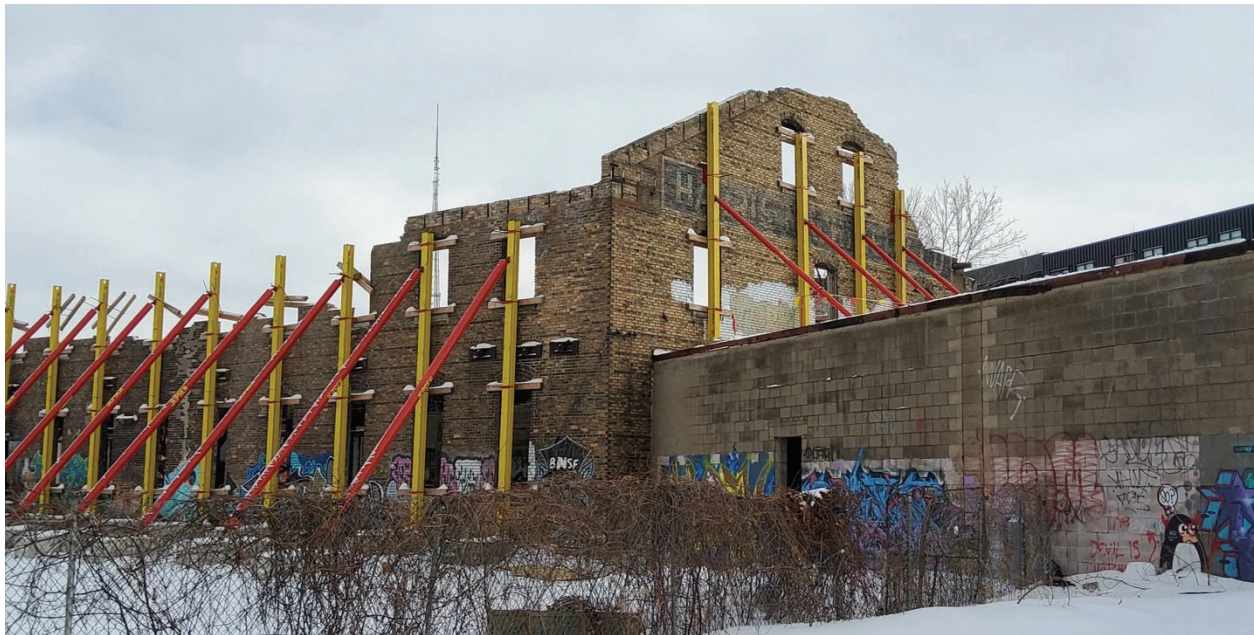
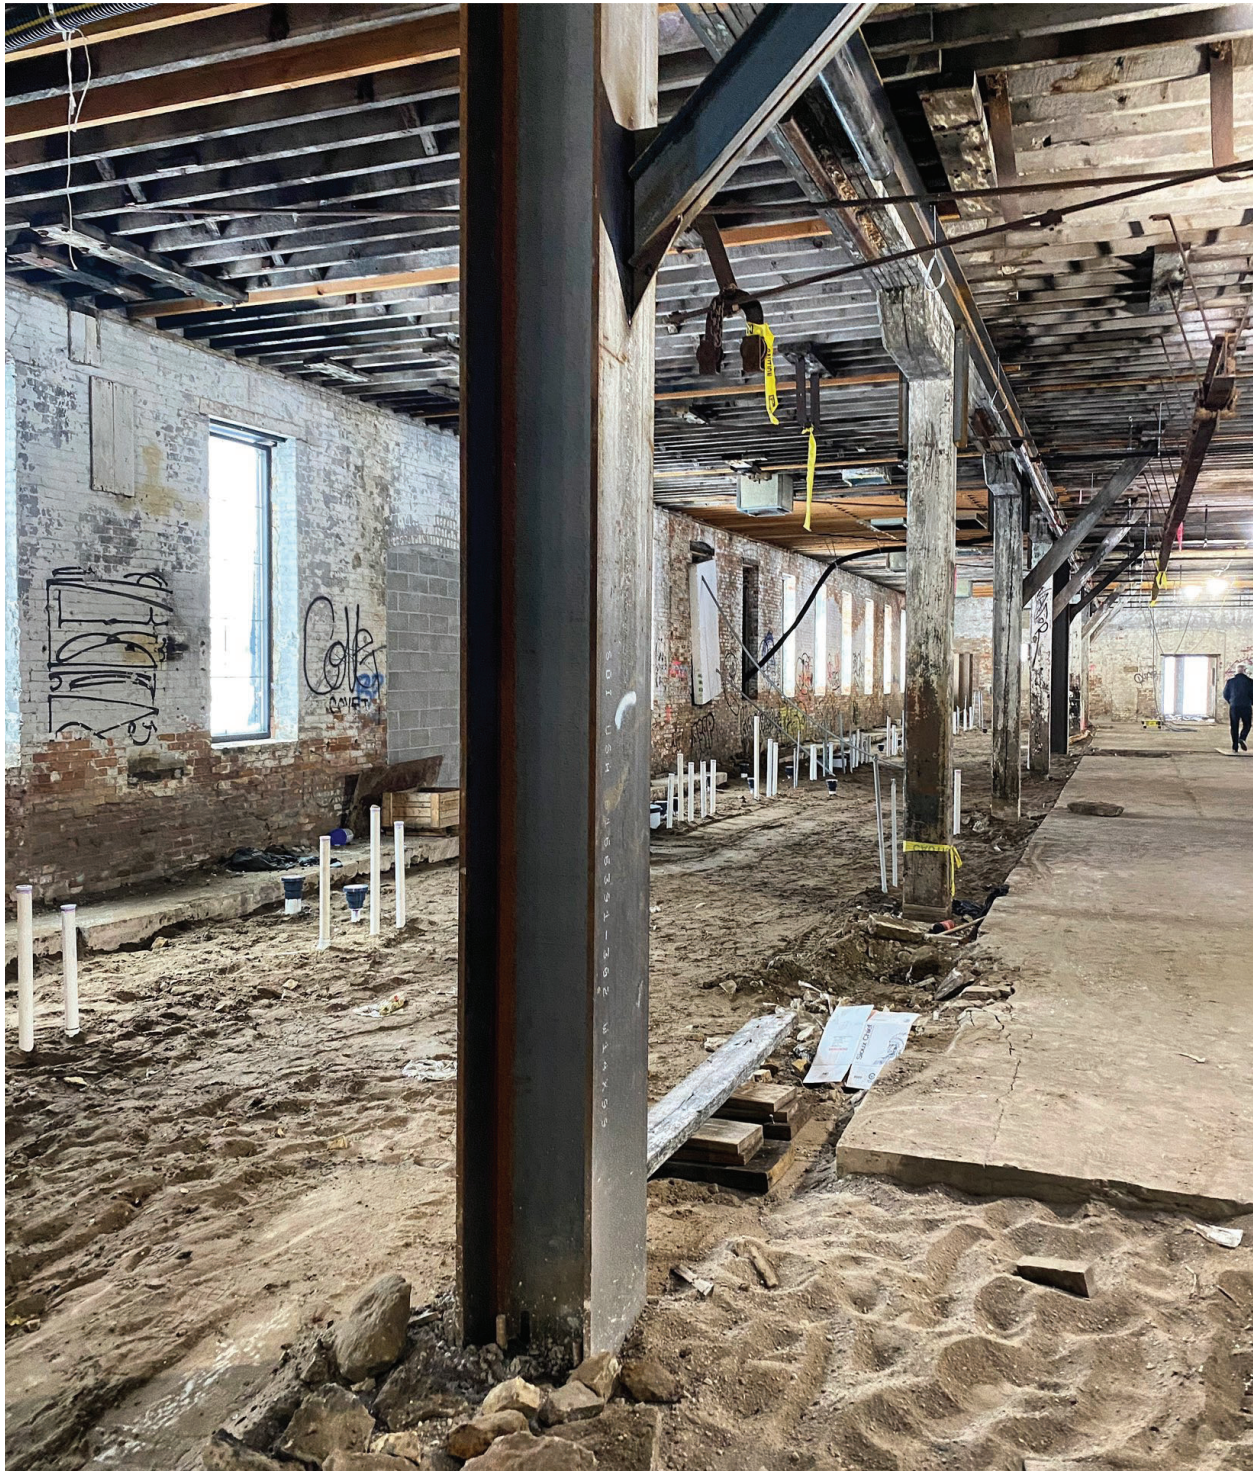
Malcolm Yards Market – DURING Construction

One particularly effective method we propose using for this project is Rake Shoring to support the exterior walls during structural modifications. This technique was successfully implemented during the Malcolm Yards Market project, allowing us to preserve a 136-year-old fire-damaged structure.

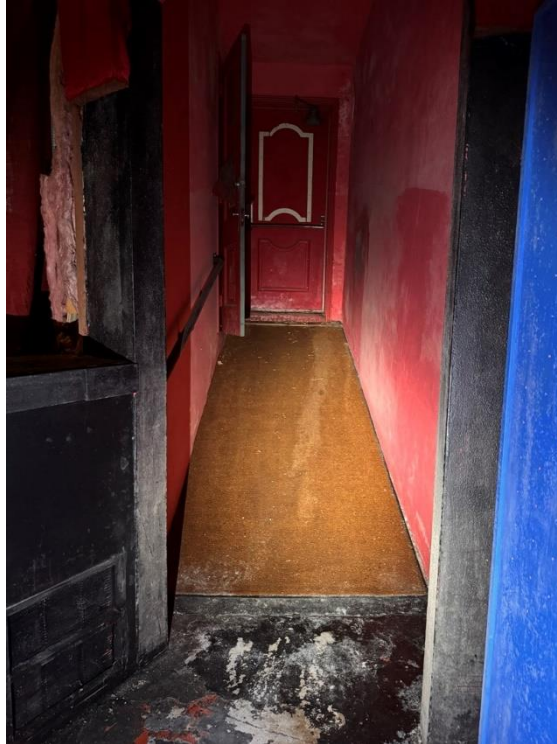
Figure 1: Narrow and steep concrete slab at egress

- a. Recommendation: Amend both egress ways by demolishing and reconstructing the structural concrete framing over the mechanical basement area at the 'north' end of the building. Some reconfiguration of the basement mechanical may be necessary to allow for this reconstruction and for clearance for proper egress. See Figures 1 and 2.

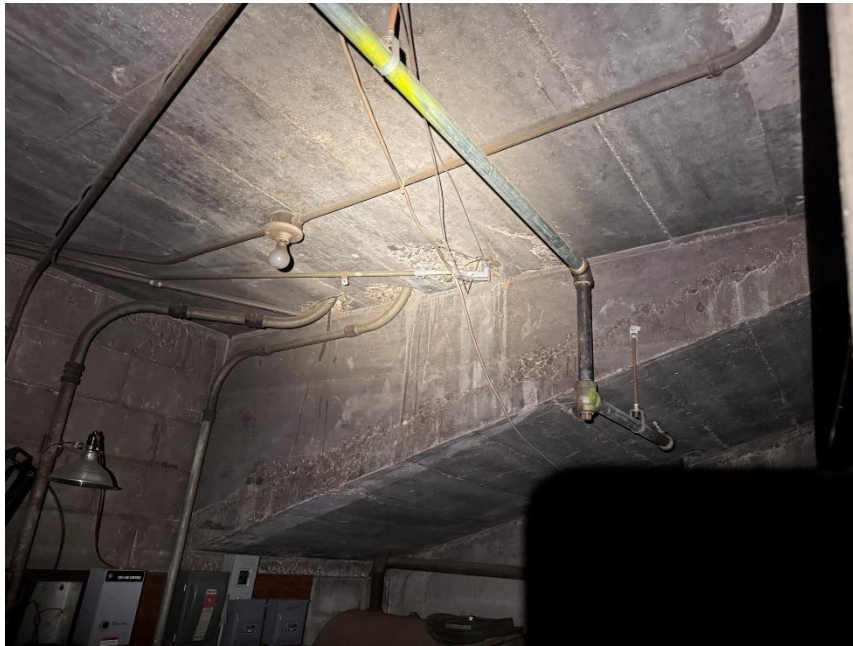
Figure 2: Concrete construction at steep egress ramp

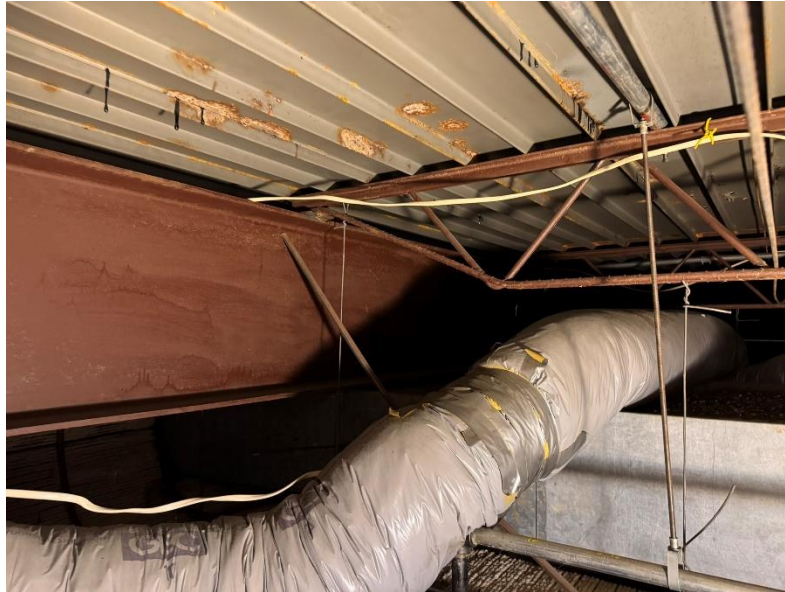
Figure 3: Steel roof framing (not at roof leak area)

1. As noted previously, it was observed that there is an active roof leak that is allowing moisture to enter the main theater space. Where we were able to observe the roof structure through openings made in the ceiling finishes, the steel roof joists bottom chord rods (deformed 'rebar' rods) have very minimal protective coating and have areas of surface corrosion. The steel roof deck also has spotty evidence of corrosion. The steel beams appear to have a more intact primer or coating protection. Exposure to moisture accelerates existing or previous corrosion effects.

- a. Recommendation: Where the roof is experiencing water intrusion, we recommend a plan to address corrosion and deterioration at the adjacent structural steel deck and steel joists. We recommend that an inspection be made of the whole roof area to investigate the extent of structural deterioration that will require structural work. See Figure 3.

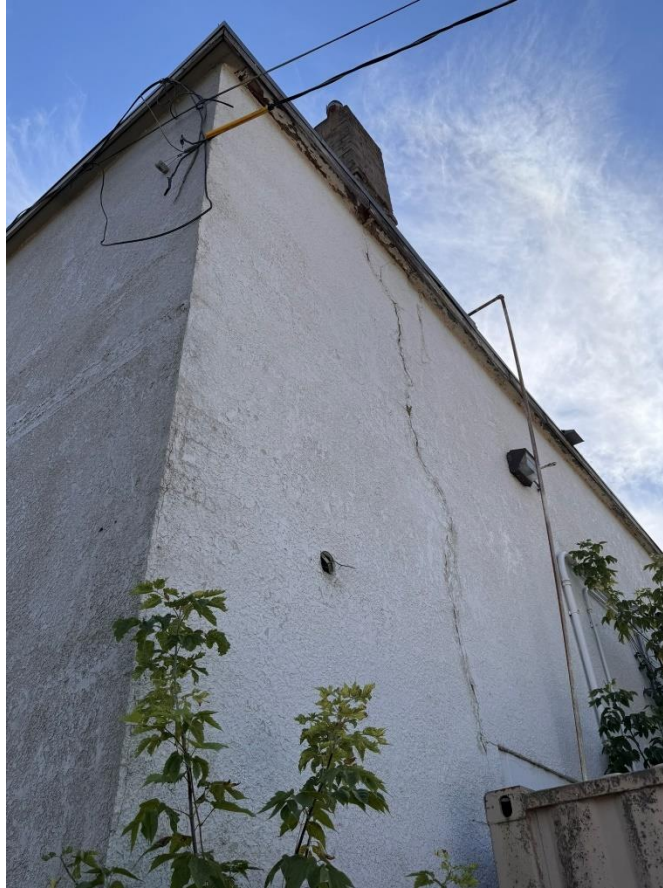
Figure 4: Vertical crack at back wall of building

1. A significant vertical crack was noted at the back wall of the main theater building wall in the stucco exterior. It is expected that the crack extends through the wall and is not just a shrinkage crack in the stucco material. This crack may be related to other cracked conditions at the

northeast portion of the building. See below of overall recommendations related to foundation conditions and the exterior wall.

4. The three incidents of wall cracking at the back wall, basement CMU, and exterior east wall indicate that there has been some settlement of the foundation condition at the 'northeast' portion of the building. Although significant structural distress has not yet been noted, there is potential for additional differential structural movement. Additionally, a review of the soil borings acquired in 2005 by Bruan Intertec and reproduced in AET's geotechnical report dated August 11, 2023 shows that there is a layer of organic clay material immediately adjacent to the Dock Cinema building east wall. This location of this weaker soil layer coincides with the stair step cracking in the east wall and may indicate a generally softer soil condition at this northeast area of the building.

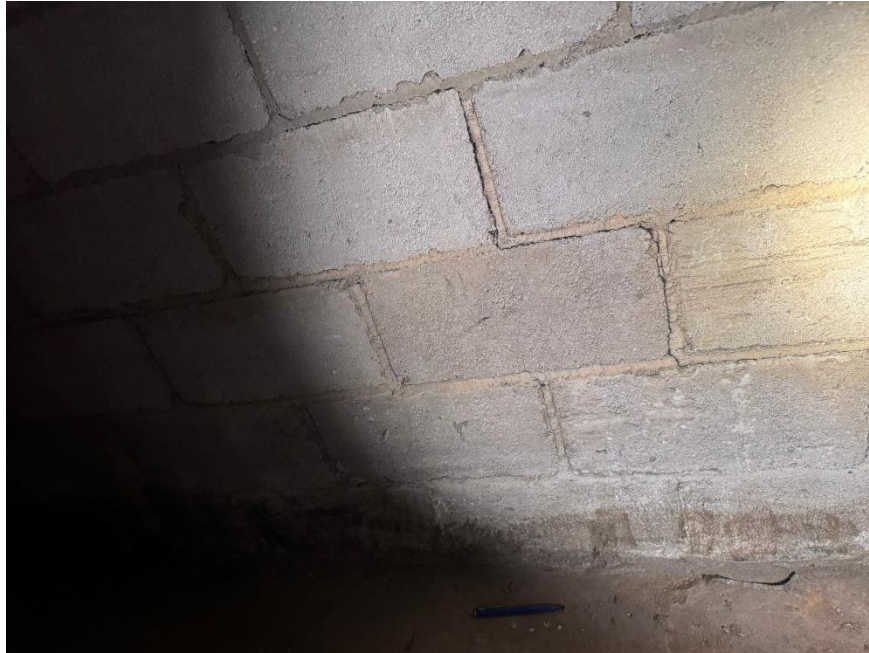
Figure 5: Basement wall cracking adjacent to east wall (looking south)

2. There is a small partial basement level housing mechanical equipment at the north end of the building. The access to this level is limited to one narrow door and stairway. The basement is constructed with both cast-in-place concrete and concrete masonry walls. At the east end of the south wall of this basement area, stairstep cracking was noted in the masonry wall indicating settlement of the foundations and east wall of the building has occurred. See Figure 5. Refer also to recommendations below of comments regarding foundation conditions at the east wall.

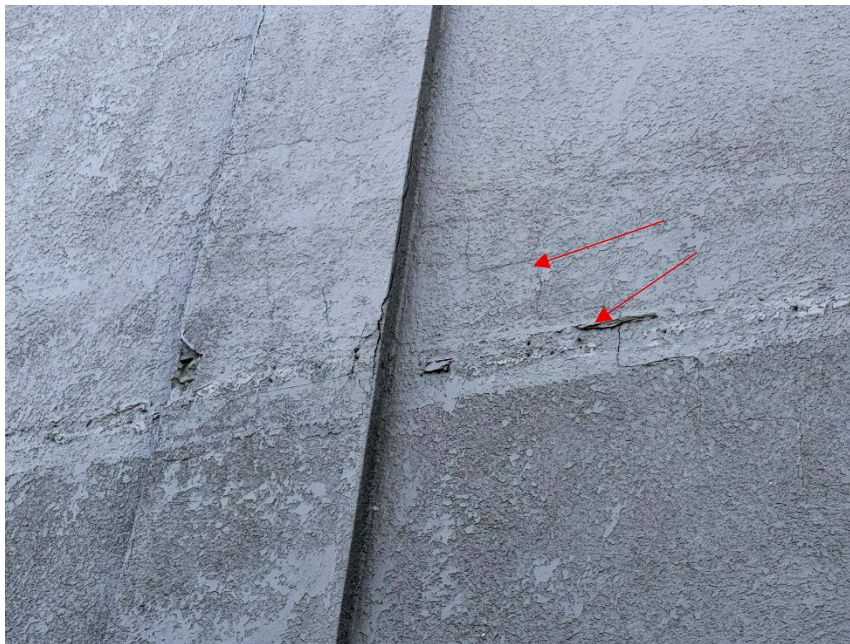
Figure 6: Cracking at east (lakeside) wall

3. At the 'east' (lake side) exterior wall facing the empty lot additional stair step cracking was noted at about the 1/3 point location (from the back wall). The cracking projected through the exterior stucco finish and appeared to correspond to a concrete block module (8-in high and wide step increments). See Figure 6.
